PRESIDENT
EDWIN C. GENT, P.E.

May 24, 2010

Re: Crotty Residence
87 Trafford Rd.
Binghamton, N.Y. 13901

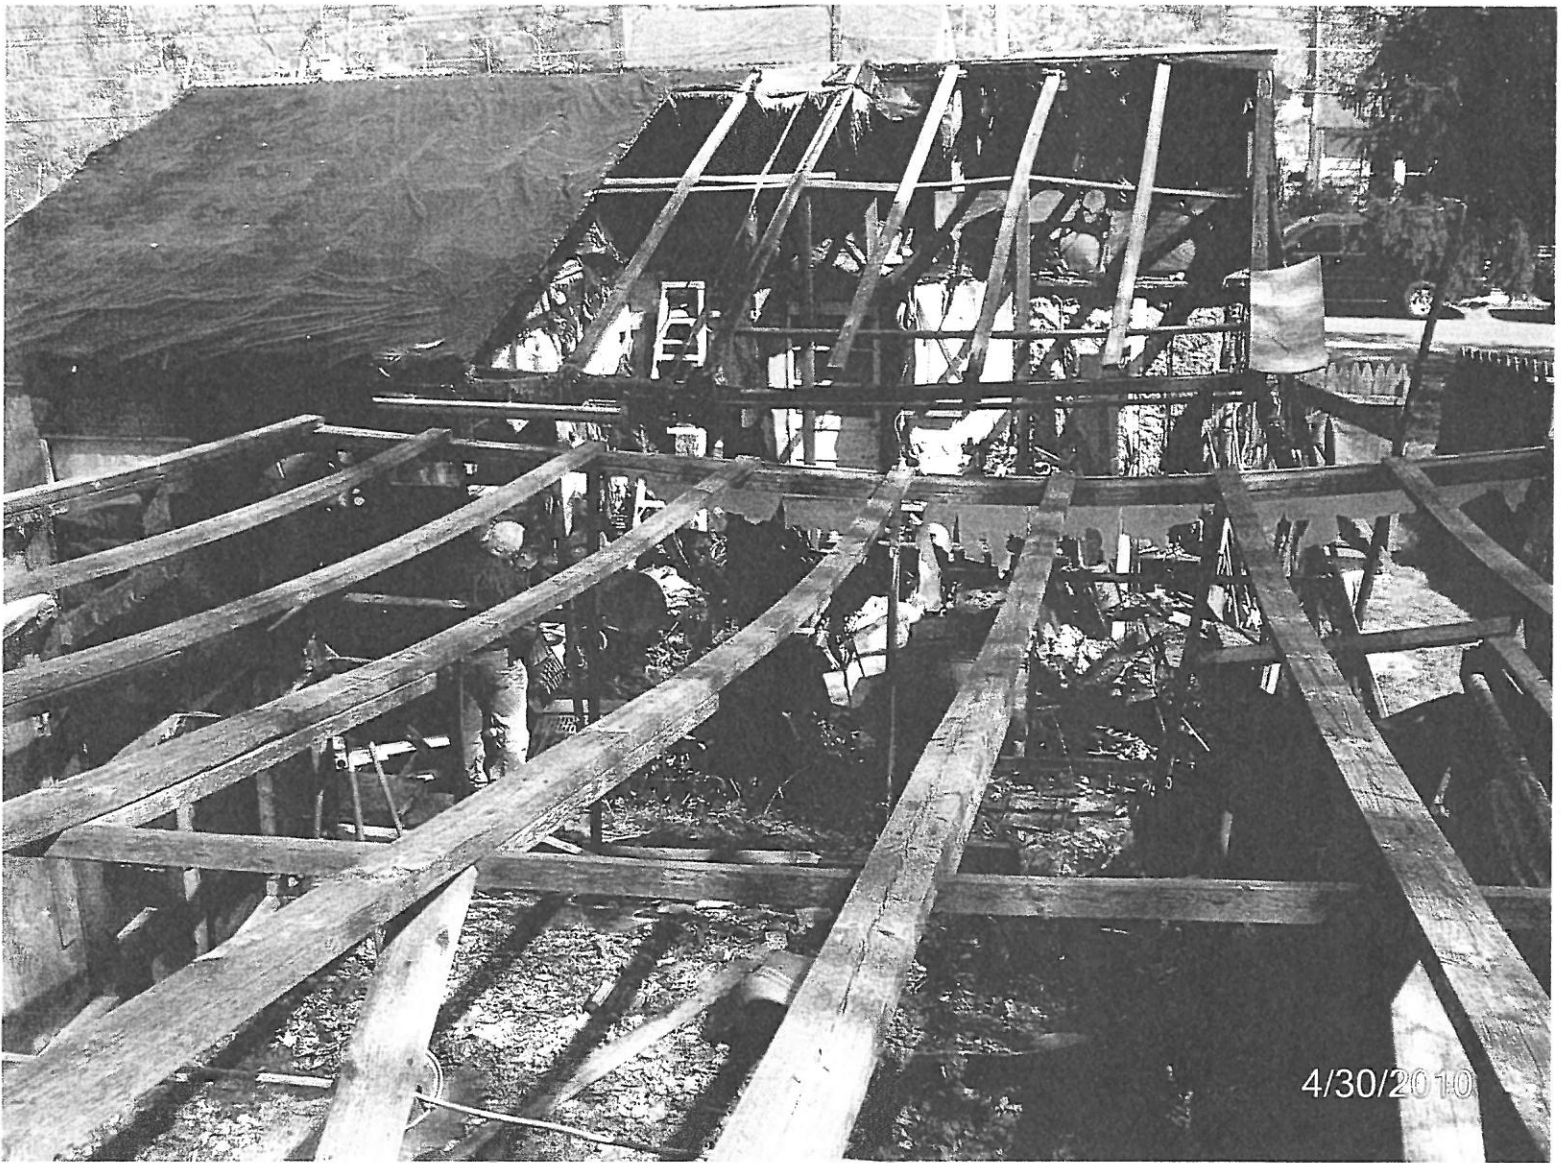
4/30/2010

The inspection revealed that the fire was small and confined to an existing grille located inside an enclosed rear patio area. Copies of photos are attached.
